# Intel<sup>®</sup> I/O Controller Hub 10 (ICH10) Family

## Specification Update

**December 2011**

Document Number: 319974-015

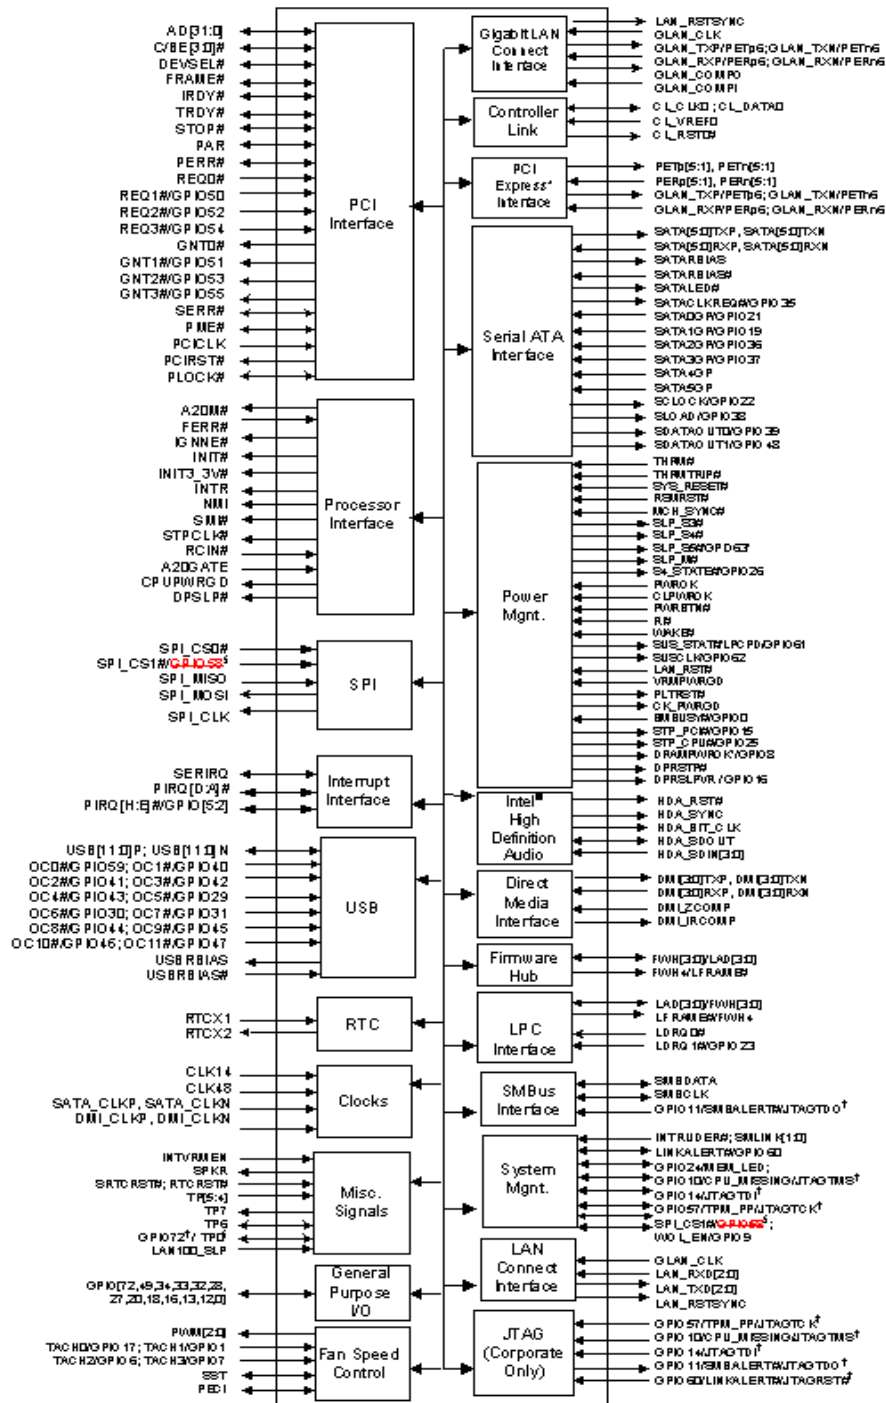
Figure 2-1. Intel® ICH10 Interface Signals Block Diagram

**9. Remove GPIO58 from Figure 2-1, Intel® ICH10 Interface Signals Block Diagram**

Update the following block diagram in Section 2, Signal Description, in the Datasheet.
